Gleaner rotor reinforcement

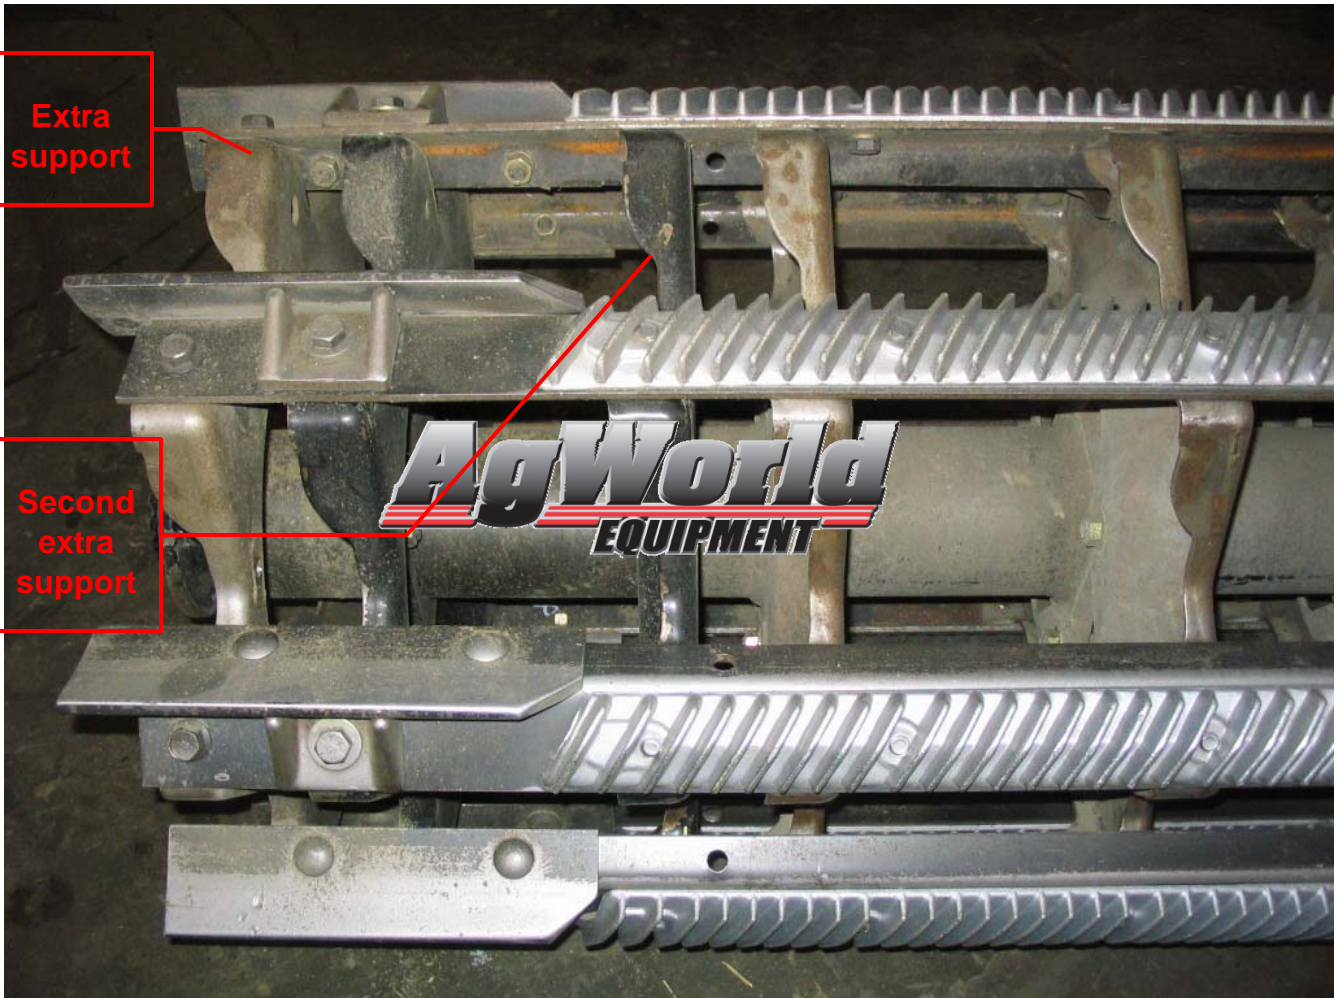
Extra support

This modification consists of two extra spiders and extra lugs to increase the rigidity of the discharge end of the rotor. Since this dealership has been installing the reinforcement, failures in this area have been practically eliminated, with the exception of foreign material damage, (rocks, roots, metal ...etc.).

Installation of the reinforcement requires the removal of the rotor. Extra holes have to be drilled to mount the extra lugs and the spiders. One spider can be installed without disassembling the rotor but it has been found that two are required to provide the strength needed. After installation of the reinforcement, the rotor **MUST** be statically balanced, reinstalled in the machine, and then engage the separator and run up machine checking for vibrations.

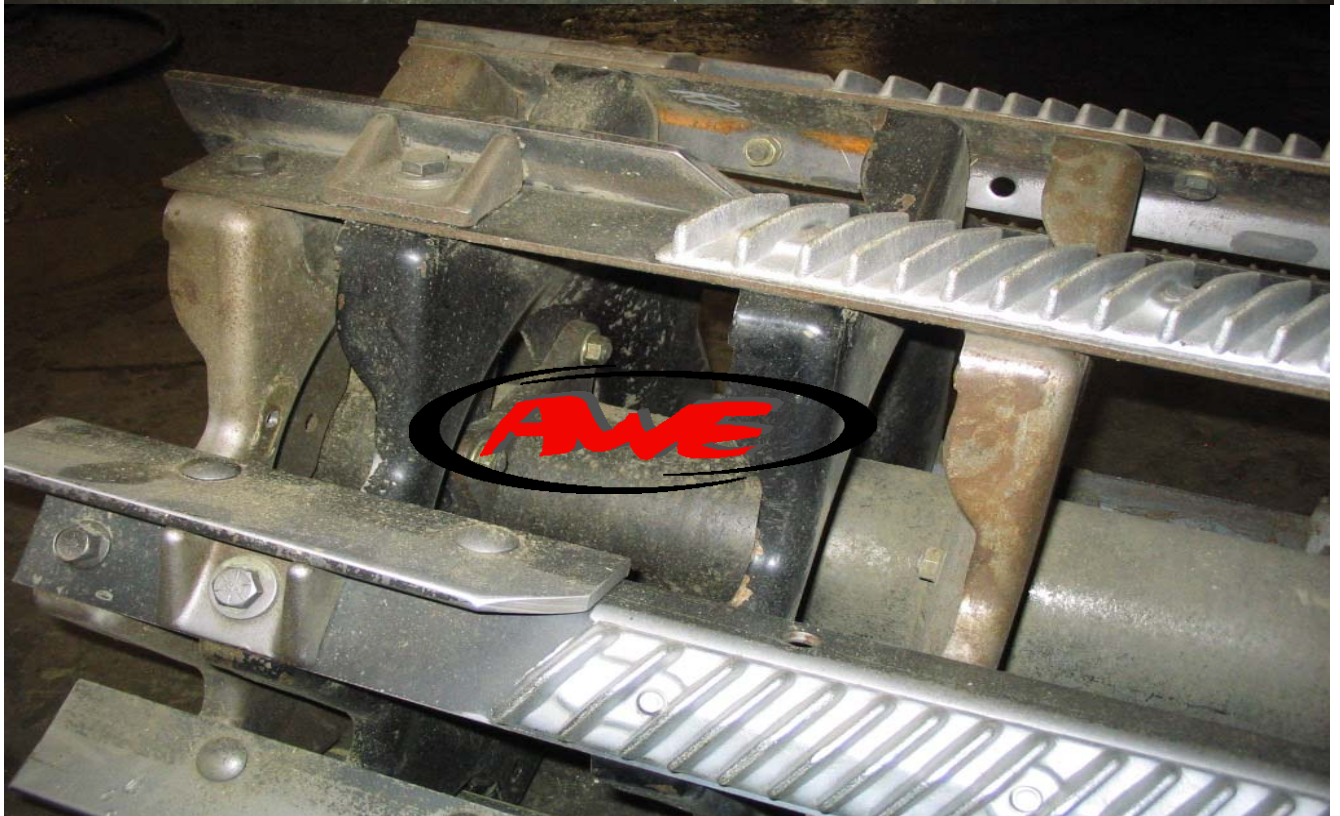
Second extra support
