Massey-Ferguson 9000 series rotary combine straw chopper drive modification.

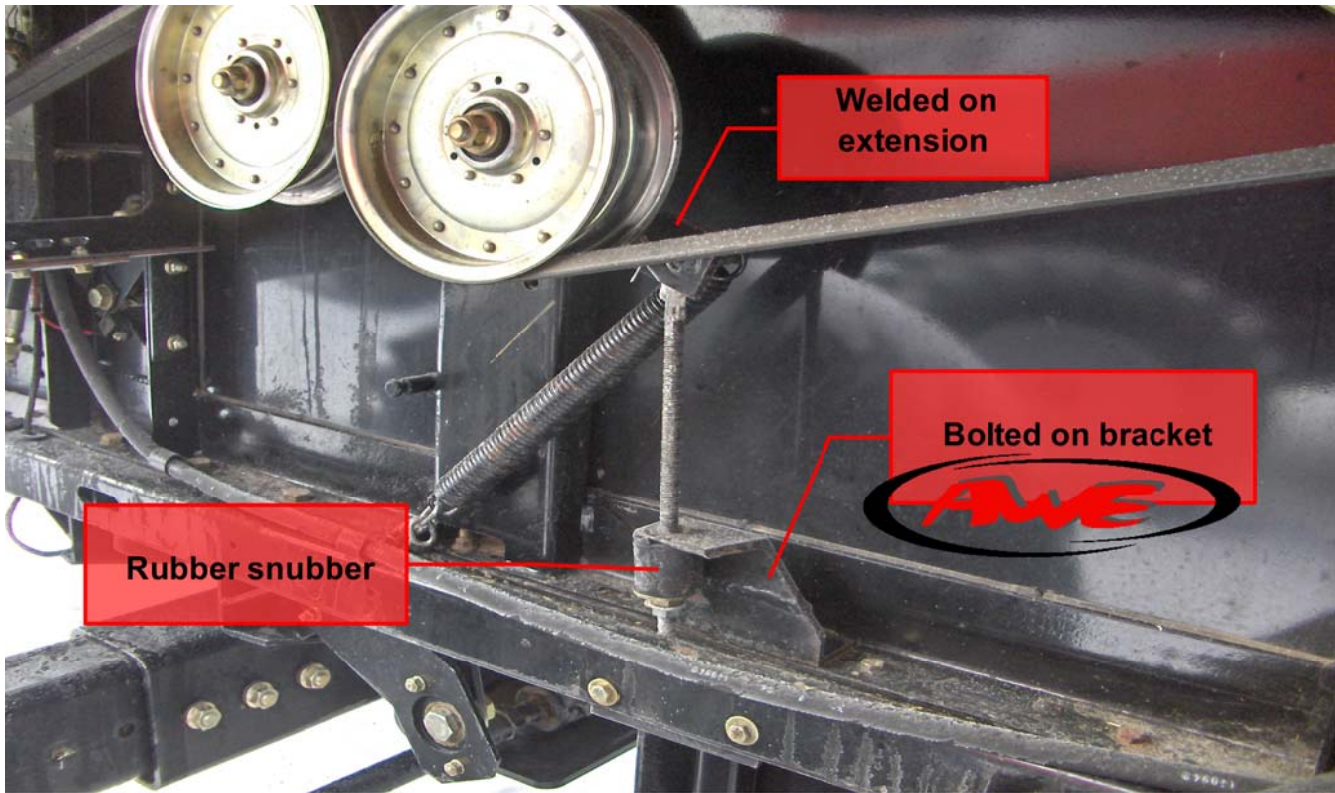
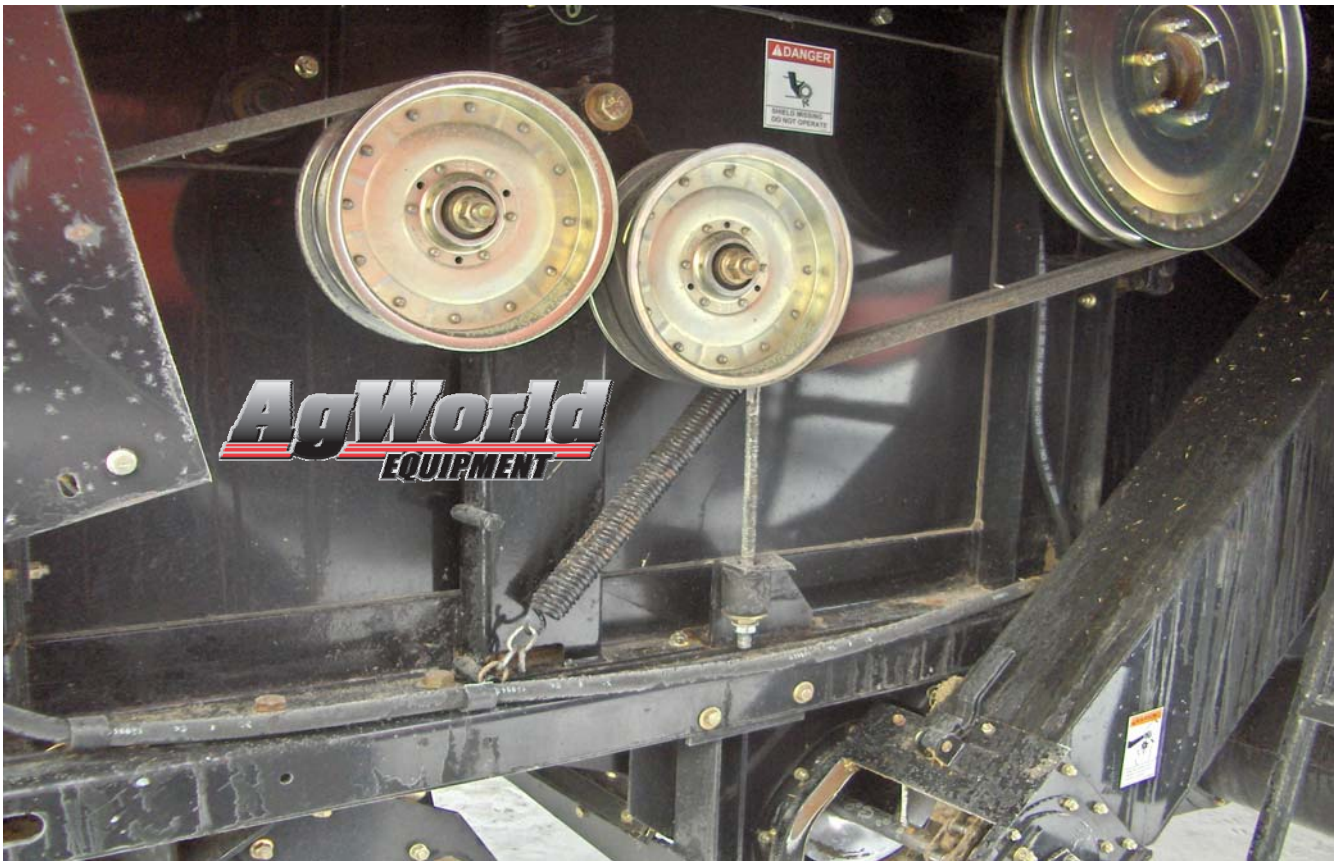
The original straw chopper drive on the Massey-Ferguson 8000/9000 series combines requires a daily check/adjustment to operate properly without any unwanted downtime due to belt failure. The chopper drive consists of a primary drive belt and a secondary drive belt. The primary belt is the first one off the main countershaft, and runs down to the chopper jackshaft. The secondary belt runs from the jackshaft to the chopper itself. The secondary belt is tensioned by an adjustable spring on two tightener pulleys. The arm that the tightener pulleys are attached to has an adjustable stop to act as a snubber. The snubber will stop the arm from rotating forward, to keep the belt tight. As the belt stretches, the snubber or mechanical stop has to be adjusted. Under tough or wet conditions, the belt will stretch a lot making the operator have to adjust the snubber a lot. When the combine is working properly, and is full with material, the chopper has a specific load in it. The top strand of the belt is pulling the chopper pulley, turning the chopper. This top strand is under load and is being pulled extremely tight by the jackshaft pulley, and the bottom strand is held tight by spring tension. If the operator is running the machine with the snubber not adjusted, what will happen is the tightener arm will be allowed to move forward, allowing the belt to run loose. With the combine operating under a comfortable load, there will be a specific load on the secondary chopper belt. Then, if the combine swallows a tough wad and when that wad goes through the chopper there is an increase in the load on the secondary chopper belt. The instant that the wad leaves the chopper, suddenly there is no load on the chopper belt. The chopper operates at such a high speed that when there is suddenly no load on the belt the chopper acts as a jackshaft and will momentarily try to drive the belt instead of the belt driving the chopper. This will, if the snubber is not adjusted right, allow the belt to loosen and whip. When the chopper load resumes the belt load will resume. If the load is sharp enough on the loose, whipping belt, it can physically break the belt or at the very least damage it.

The chopper modification consists of a bolt on bracket, adjustment rod, rubber snubber, and hardware. Holes are required to be drilled in combine body to mount the bracket, and a hole in the idler arm to attach the adjustment rod. The original metal snubber is removed and a rubber bushing installed in its place. The rubber takes up the shock loading and adjustments are infrequent. This modification will eliminate the belt problem described above.
