SUBJECT: X20 COM 1 Error

Effective serial number range: X20 monitors with serial numbers greater than A2745100765

TSB # 14-2011

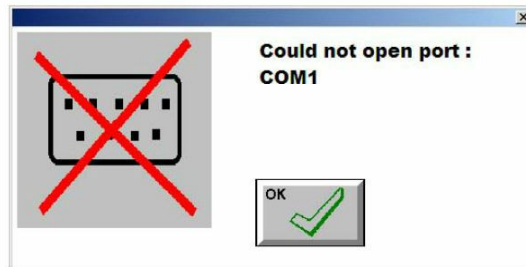
Topcon recently made changes to the Guidance software used in X-20 monitors. An oversight has resulted in an error being created when the guidance program is opened. This error results in COM 1 not being able to communicate as well as your path not being “painted” in the guidance program. This results in the guidance program not being able to create a coverage map, then guidance is unable to automatically turn the clutch on or off at headlands etc...
