Troubleshooting AGI3 communication issues

RE: KO1024373

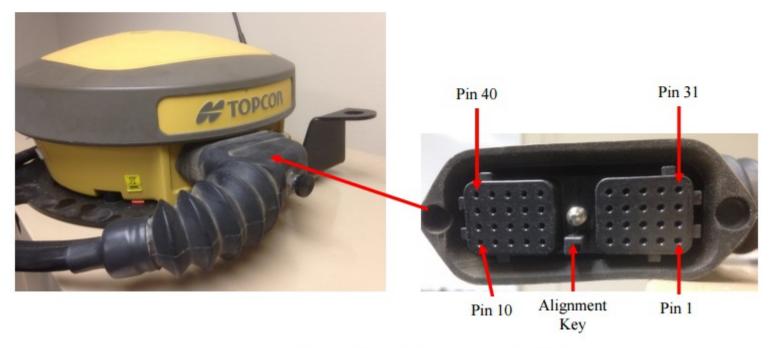
Figure 2 - AGI-3 Round Bulkhead Connector

Check the AGI-3 round bulkhead connection that is mounted or located on the rooftop. (reference Figure 2) Check continuity of the RS 232 TX, RS 232 RX, and RS 232 ground wires from the AGI-3 to GX-45 terminal or the AGA4412 adapter harness.

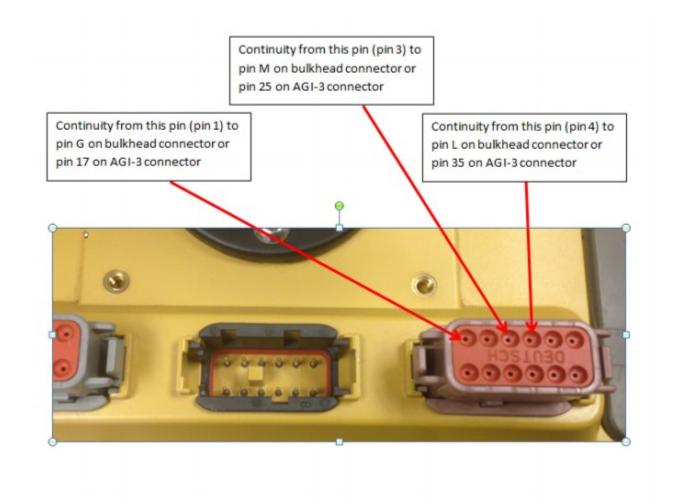
Figure 3 – AGI-3 Receiver 40-Pin Connector

- a. To check RS 232 TX-- from 40-pin connector on AGI-3 (reference Figure 3), check continuity from pin 35 to pin L on bulkhead connector and pin 4 on brown 12-pin Deutsch connector at GX-45
- b. To check RS 232 RX –from 40-pin connector on AGI-3, check continuity from pin 25 to pin M on bulkhead connector and pin 3 on brown 12-pin Deutsch connector at GX-45
- c. To check RS 232 GND—from 40-pin connector on AGI-3, check continuity from pin 17 to pin G on bulkhead connector and pin 1 on brown 12-pin Deutsch connector at GX-45.

On the left side of the connector the pins are 1 (bottom), 11 (2nd row), 21 (3rd row) and 31 (top). On the right side of the connector it should be 10 (bottom), 20 (2nd row), 30 (3rd row) and 40 (top).
